TES / AURA

Mission Operations Working Group Report

Aura MOWG
September 27, 2010

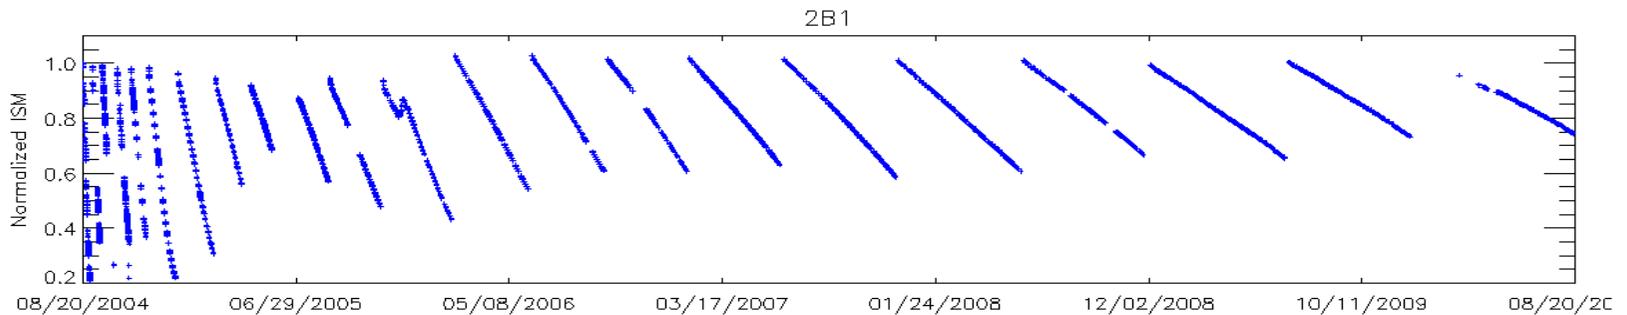
Integrated Spectral Magnitudes as Function of Days
16 pix/20 scan Averaged, Normalized to the 1st Measurement. Target: On-Board Blackbody

- Scheduled Instrument downtime this year:
 - Three day De-ice cycle commanded January, October '10
 - Periodic de-ice necessary to restore signal

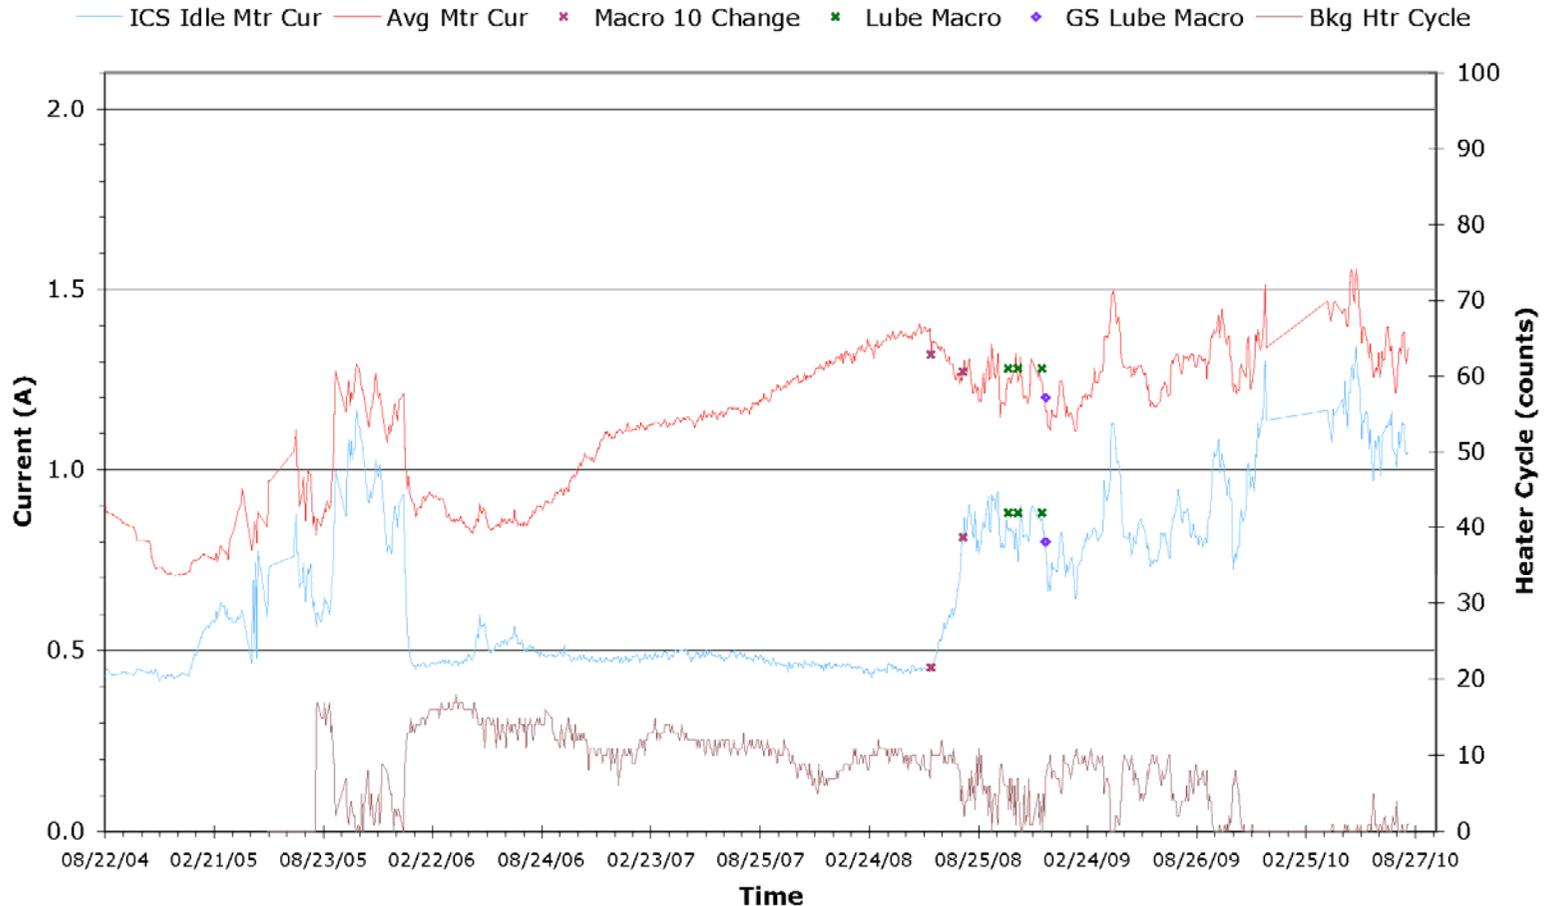
Global Survey Average ICS Motor Current Idle vs. Scan with Translator Background Heater Cycle Counts

- TES ICS (Interferometer Control Subsystem) contains a linear translator that moves a pair of back-to-back cube corners, along with motor, encoder & electronics. The linear motion of the translator modifies the optical path difference in the interferometer.
- Current increases in ICS & loss of velocity control attributed to lack of lubrication & increased friction in ICS motor encoder bearing
- Risk - eventually available current will not be sufficient to overcome encoder bearing friction; velocity instability
- TES Global Survey modified 7/08, 4/10 to reduce global coverage & reduce ICS travel - now 50N..30S
- ICS velocity control is adequate; no science impact at this time
- Contingency macros in place to raise coarse motor voltage when required
- Fault protection is enabled

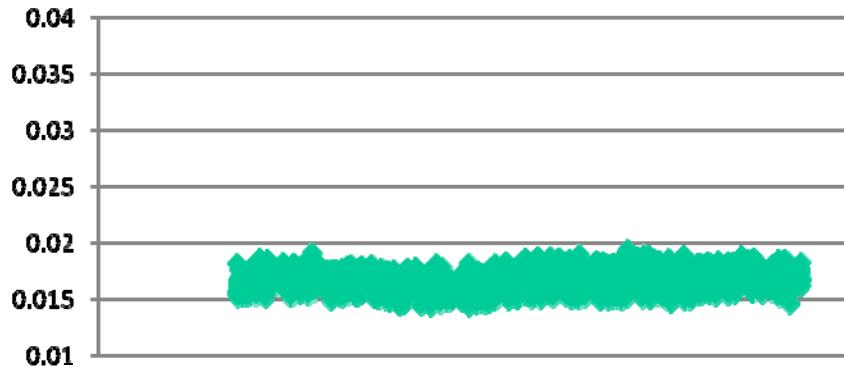
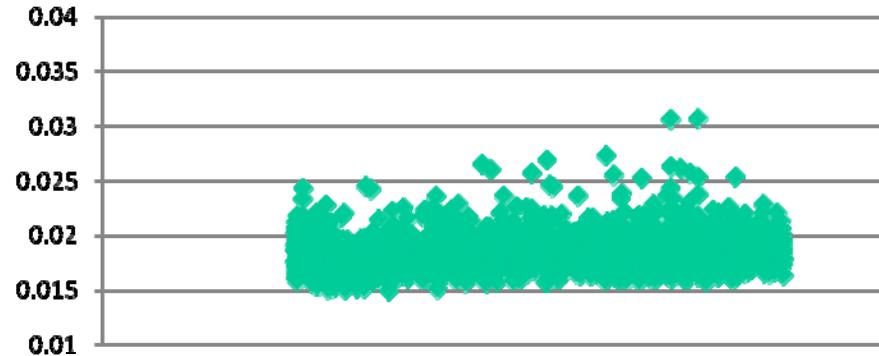
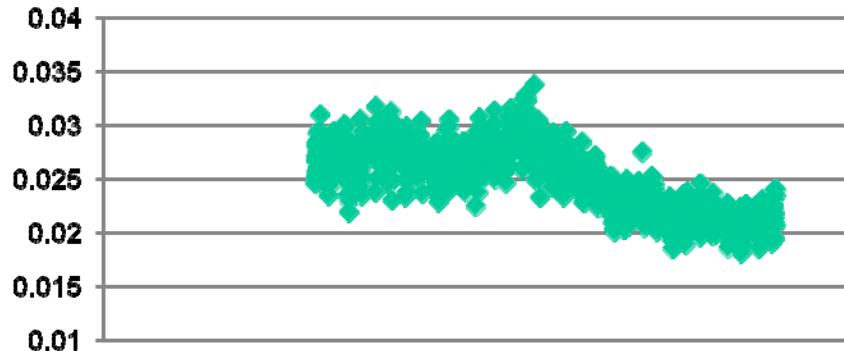
Instrument velocity data is reviewed each week, occasional over-current/velocity events detected by instrument ops team. Over-velocity fault protection is enabled on the instrument. Velocity control has degraded but science impact is minimal.

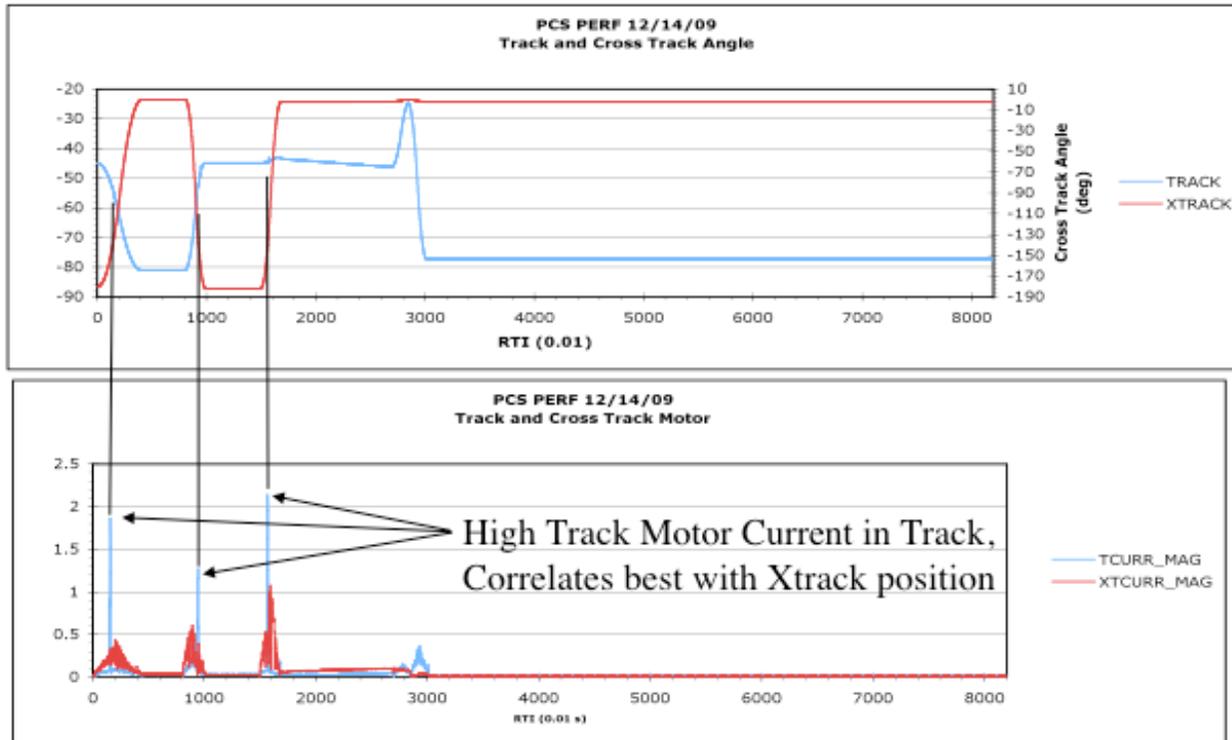
- While motion disturbances & current spikes occur on track axis, event occurrence is most closely associated with cross-track movements to / from internal black body calibration source

- Most likely failure mechanism: momentary grounding to cable shielding in **cross-track flex cable** as PCS moves to/from blackbody calibration position, causing loss of velocity sense signal from **track** motor. **Track** V-sense signal is re-established as cross-track continues motion.
- Simulations of PCS model demonstrated similar behavior with grounding of v-sense signal.
- Risk: total loss of track motor v-sense signal will place PCS at soft stops; loss of commanding.
- Additional symptom of flex cable deterioration – momentary loss of **track motor temperature** signal at certain PCS angles; also carried on cross-track flex cable & is adjacent to v-sense conductor.
- Appears to FSW as a track motor under-temperature.
- Occurs at different PCS pointing angles than v-sense signal loss; during off-nadir target tracking of special observations.

- Operations impact - TES Global Survey modified to obtain blackbody calibration scans once before & once after each global survey
 - Reducing transitions across cross-track critical angles to 2 / GS from 740
 - Obtain 40 blackbody scans pre/post global survey
 - Move PCS cross-track axis to earth-viewing angle & leave it there for GS
- Flight SW impact – none
- Ground SW impact – substantial L1B calibration code modifications required to implement modified calibration strategy, including validation
- Quality impact on data – appears to be minimal, within noise of previous product. Science data quality statement is required for L1B and L2.
- TES returned back to Global Survey Operations April 7, 2010
- Ground software updated June, 2010
- SIPS re-initiated Global Survey processing & delivery August 25th following science team evaluation
